## Clear Lake Source Water Assessment and Watershed Sanitary Survey

August 2023

## CLEAR LAKE SOURCE WATER ASSESSMENT AND SANITARY SURVEY

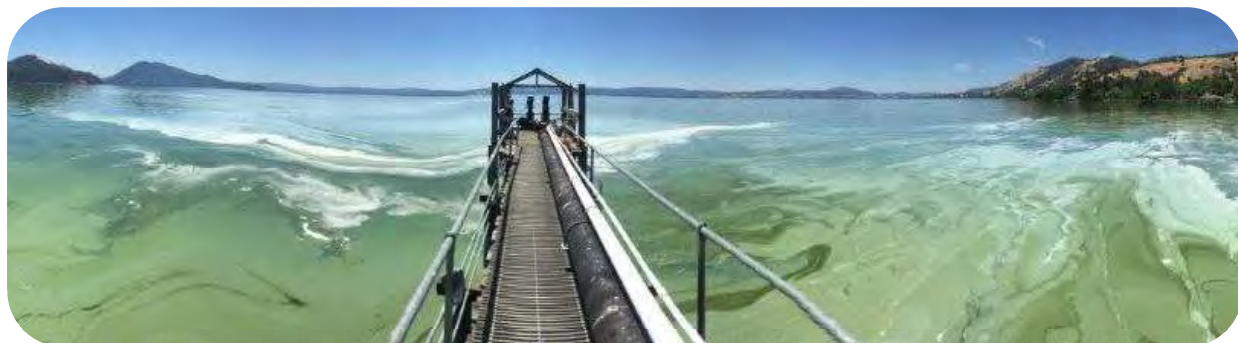
Figure 1.3.2: FHAB surrounding drinking water intake (Photo by Donny Breedlove)

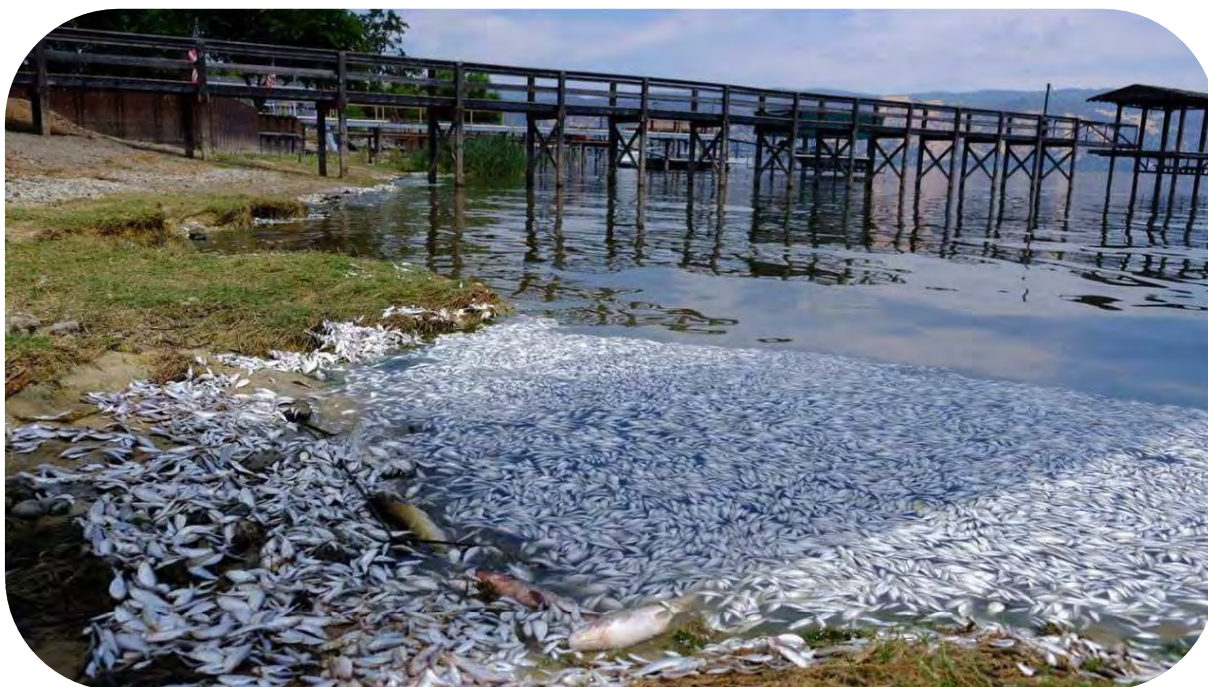
Figure 1.3.3: Fish Kill in Clear Lake, 2017 (Source: KTVU)

Decay of the HABs and algae can also create hypoxic or anoxic conditions that disrupt the ecosystem. Depleted oxygen levels limit fish habitat and may result in large-scale fish kills (Figure 1.3.3 and 1.3.4). This condition may also kill plant life and halt the development of fish eggs which significantly alters food web dynamics in the ecosystem (Michele, J., & Michele, V., 2002).

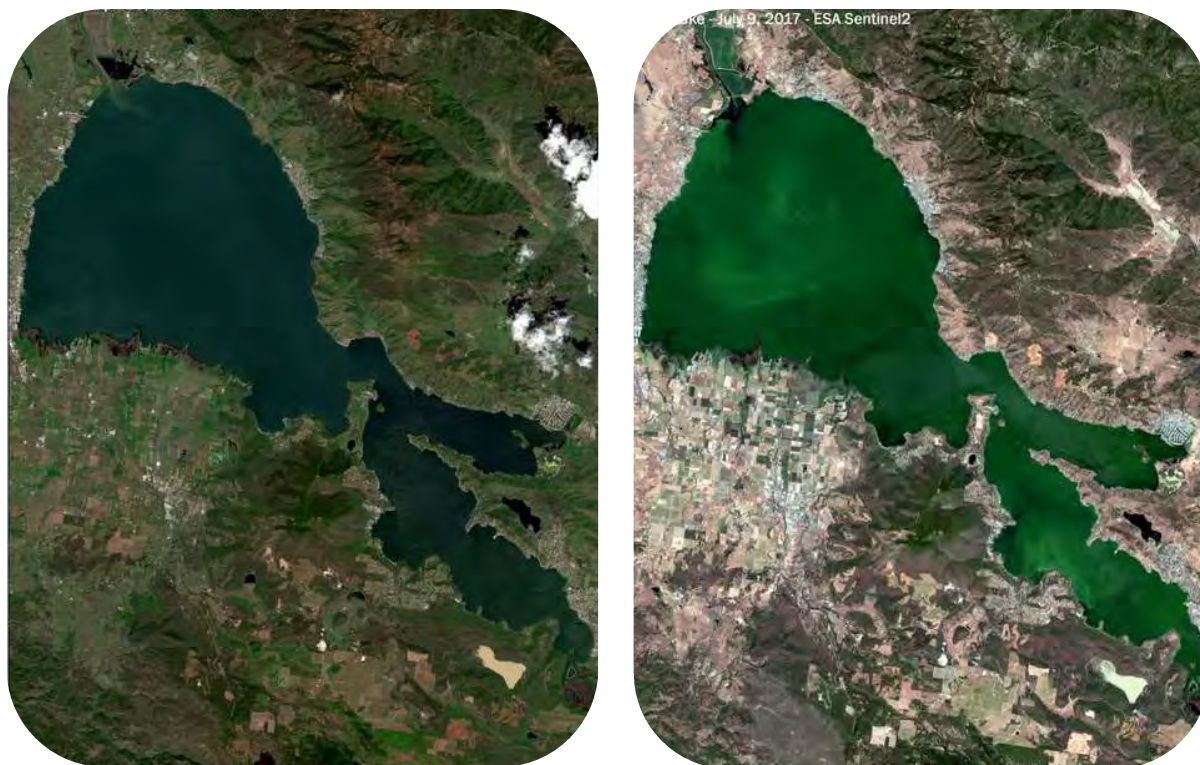
Figure 3.3.1: Algae Growth Imagery from ESA Satellite Sentinel 2

The algae cycle is largely driven by nutrient loading and warm weather. Nutrients enter Clear Lake through a variety of sources. As outdoor water temperature is beyond practical human control, potential projects intended to manage FHABs at Clear Lake should be primarily focused on capturing nutrients that are entering the lake. A description of potential nutrient loading sources and conveyance routes are described later in this report section.

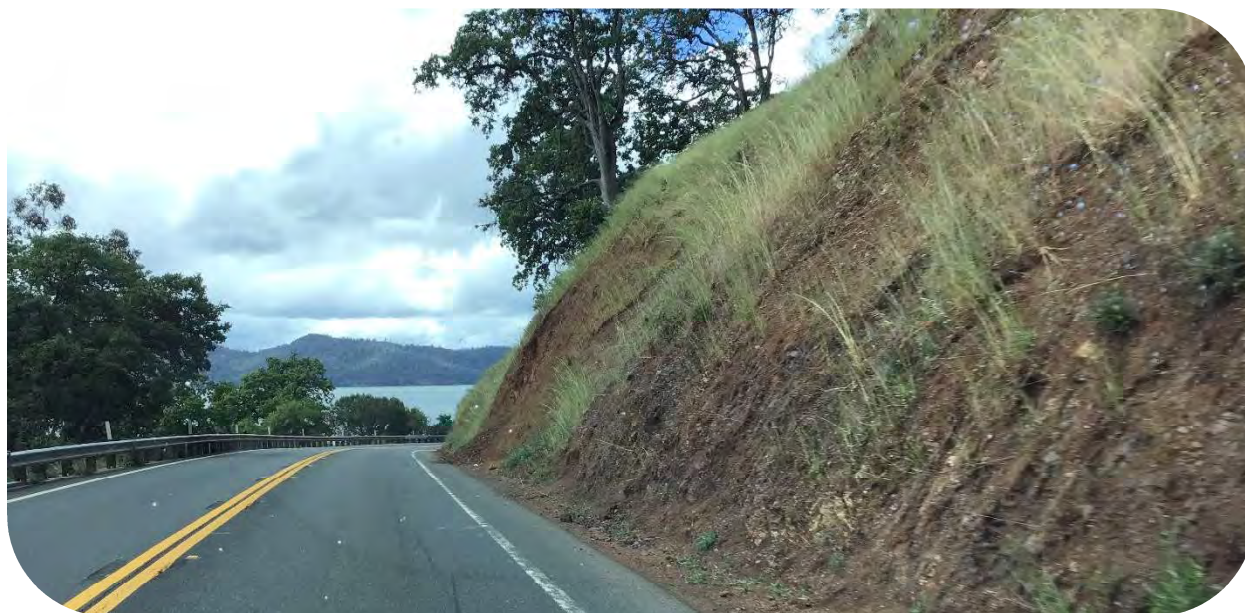
Erosion in the Clear Lake watershed is highly visible along roadways where significant cuts have been made. An example of erosion along Highway 20 is presented in Figure 3.5.2A.

**Figure 3.5.2A- Typical Erosion at the Cut of a Slope along Highway 20**

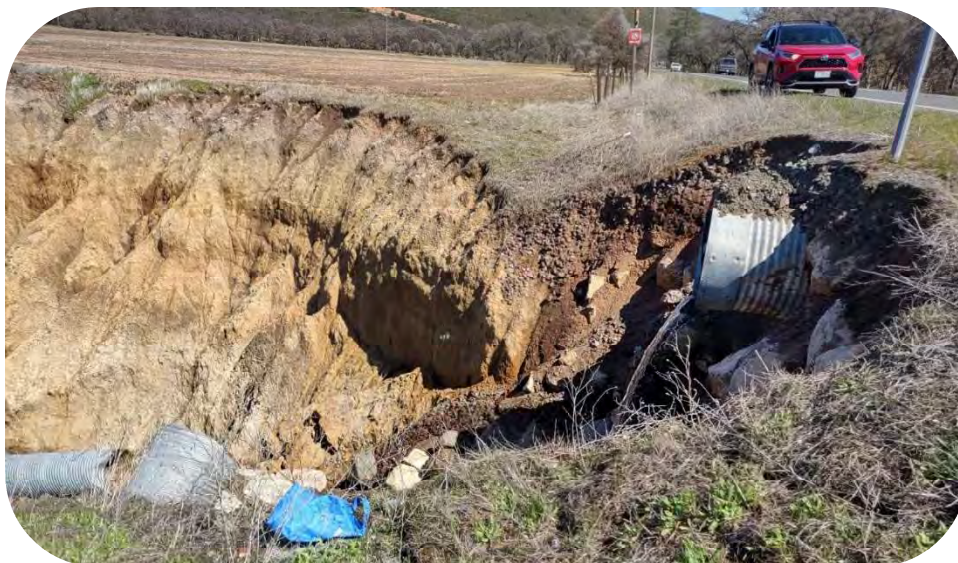
Figure 3.5.2B provides an example of how the channelization of flows into isolated culverts can accelerate erosion. This is an extreme case that was reportedly partly due to a failed spillway. It was exacerbated by the concentration of flows into a single culvert that drains to Thurston Lake. Roadways, related drainages, and associated runoff is considered a viable first phase target for implementing various BMPs to address non-point loadings.

**Figure 3.5.2B- Example of Severe Erosion on Nearby Highway 29 South Of Clear Lake**

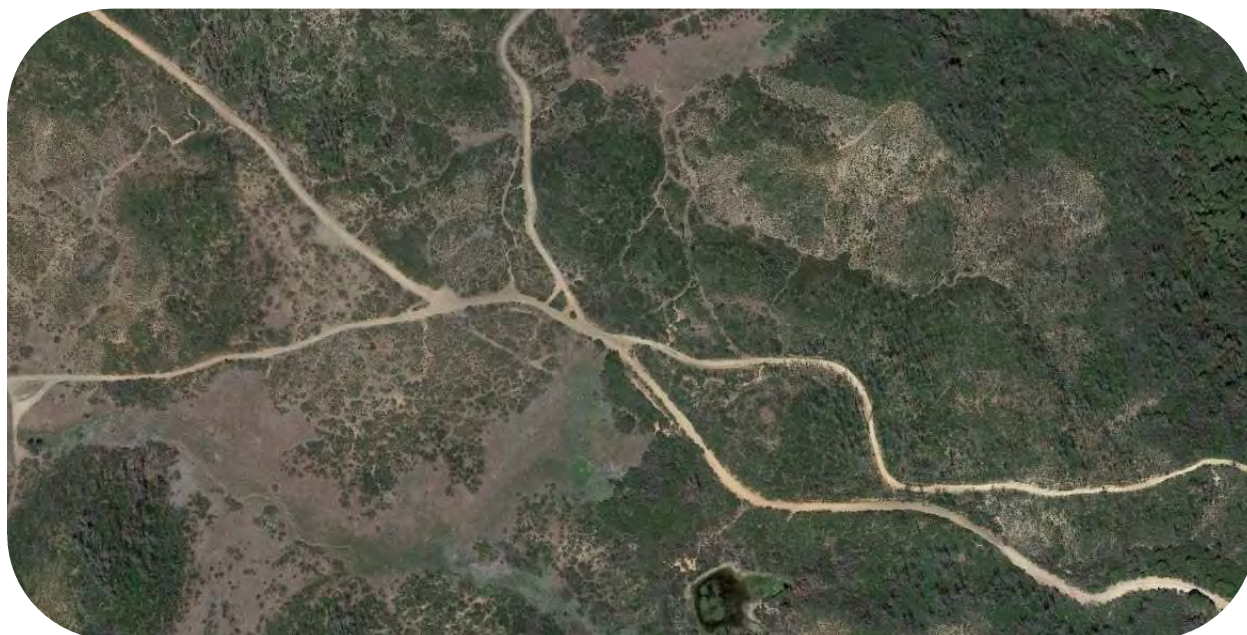
Figure 3.5.4- Cow Mountain OHV Trails

- Steep slopes, dirt roads, and off-highway-vehicle (OHV) trails can be a source of sediment contribution from erosion. Cow Mountain OHV trails are illustrated in Figure 3.5.4.
- Timber harvesting requires the use of heavy equipment that can promote erosion or push sediments into streams
- If used, forest management chemicals can pollute watersheds

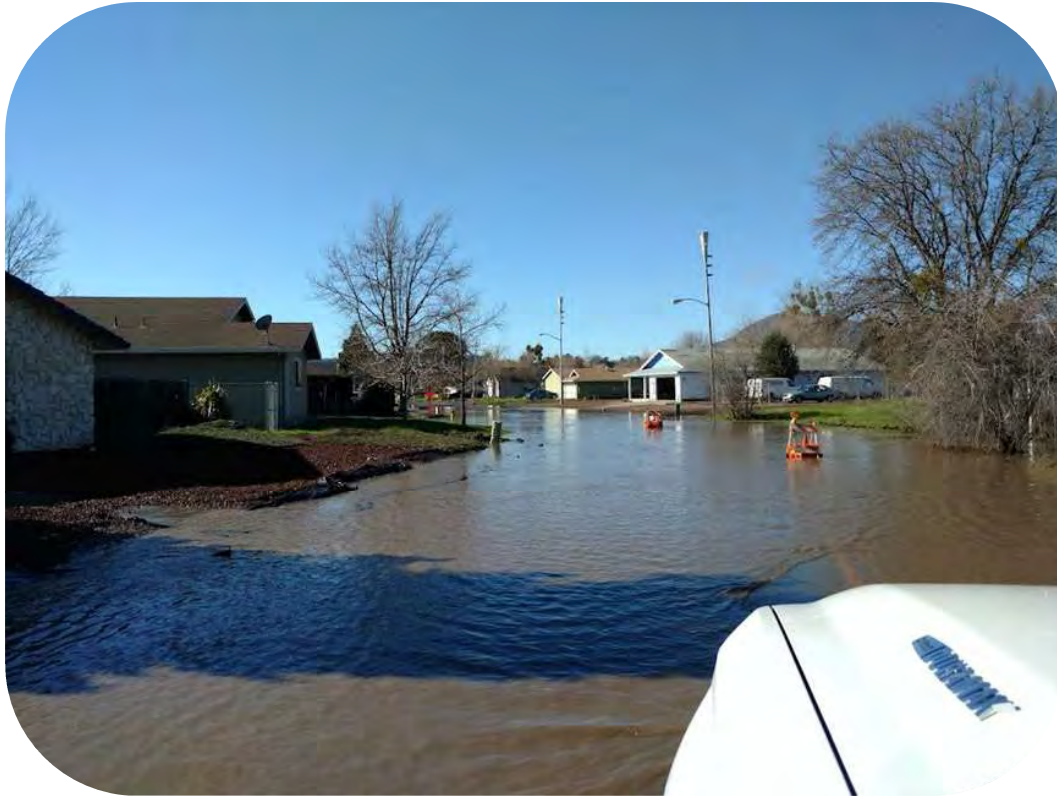
Figure 3.5.6  
Flooding of Streets and Underwater Manholes (Keys Blvd Feb. 2017)

The treated wastewater effluent forcemain on the north side of the lake could provide an opportunity to convey flows from failing septic systems by implementing STEP (septic tank effluent pumping) or additional gravity sewers near existing collection systems. The conditions associated with the flood events pose relatively high threats for SSOs now and into the future and the related water quality implications should be considered in future investigations and mitigation related projects. Existing septic systems and leach fields are also more vulnerable and much less effective in retaining domestic leachate during periods of high rainfall and high groundwater.

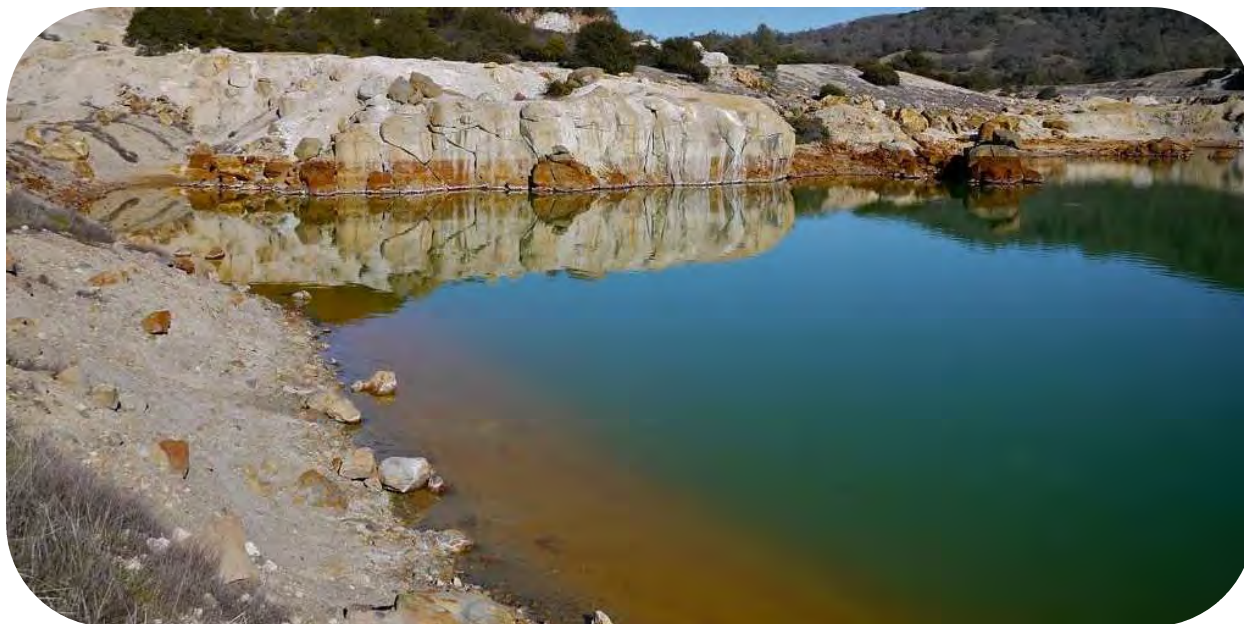
**Figure 3.5.9- Acidic Water in the Flooded Herman Pit, Sulphur Bank**

This site has been selected by the EPA as a superfund site, and long-term plans are being developed to contain waste, fill the Herman pit, and cover it with vegetation. Further information about EPA clean-up activities can be found at the EPA [superfund website](#) and in a recently published EPA handout (Attachment E).

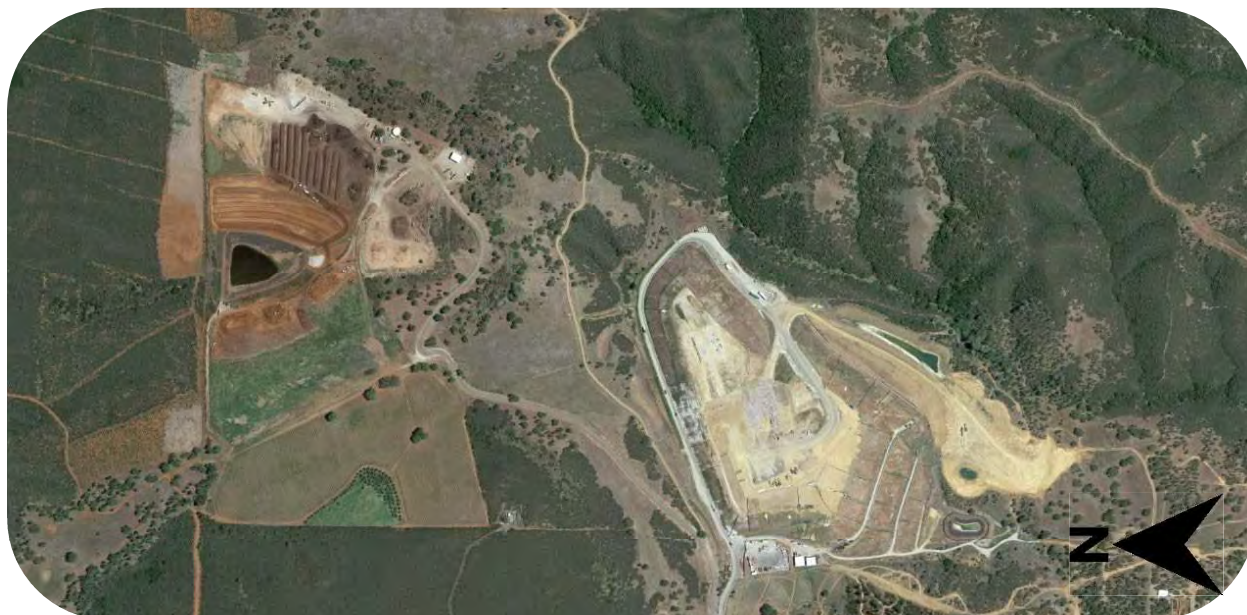
Figure 3.5.11: Eastlake Landfill Area Imagery from Google Earth

Eastlake Landfill, seen in Figure 3.5.11, is the only landfill in the Clear Lake watershed. It has been in service since 1972 and is owned and operated by Lake County. The landfill is currently being expanded to manage a rising demand over the last decade. The landfill is located east of Clearlake in the foothills on its own isolated hill. The landfill is used as a buffer for the waste treatment facility. There is currently no indication that contaminated groundwater has entered Clear Lake from this landfill. More research can be done to investigate any impacts this landfill may have on the nutrient loading in Clear Lake.

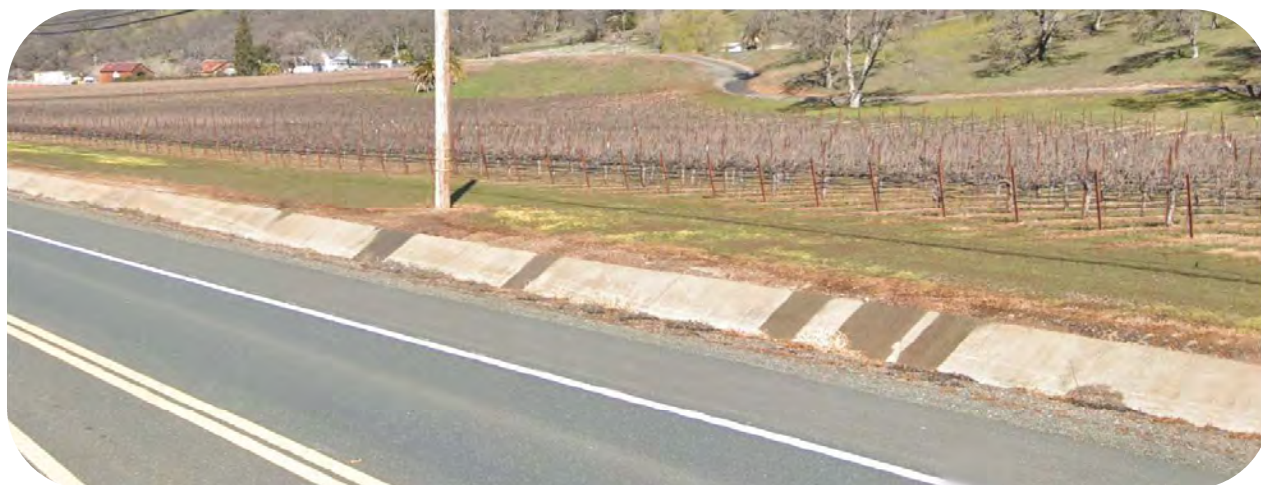
Figure 5.2.2 Concrete Drainage Channel in Clearlake Oaks (along north side of Hwy 20)

The Clearlake Oaks Keys are a subdivision of single-family homes located on the North Shore of Clear Lake along Highway 20. These homes have been constructed with over 6.5 miles of waterfront channels. The channels have poor circulation and exhibit some of the most extreme algae and aquatic weed blooms on the lake. The keys can contribute to poor water quality in Clear Lake by spreading algae and weeds to other areas of the lake, and by “banking” nutrients in the channels. Nutrients can enter the keys channels through agricultural runoff, urban runoff, or other non-point erosion runoff. The primary inlets into the keys are Shindler Creek, the Highway 20 stormwater channel, and other stormwater inlets on the west side of the keys. Please refer to the aerial view in Figure 5.2.1 for an illustration of portions of the Clearlake Keys stormwater system.

It is anticipated that the projects will leverage USDA National Water Quality Initiative Agriculture Storm Water Implementation Funds and will be managed by the Lake County Watershed Protection District. More detailed engineering review, right-of-way research, and preliminary designs are needed prior to finalizing the most viable solutions for controlling sediment and nutrient loadings at these locations. The POA has also partnered with the Pinecrest Environmental Company and the Robinson Rancheria to acquire California Department of Fish and Wildlife (CDFW) restoration funds for related efforts.

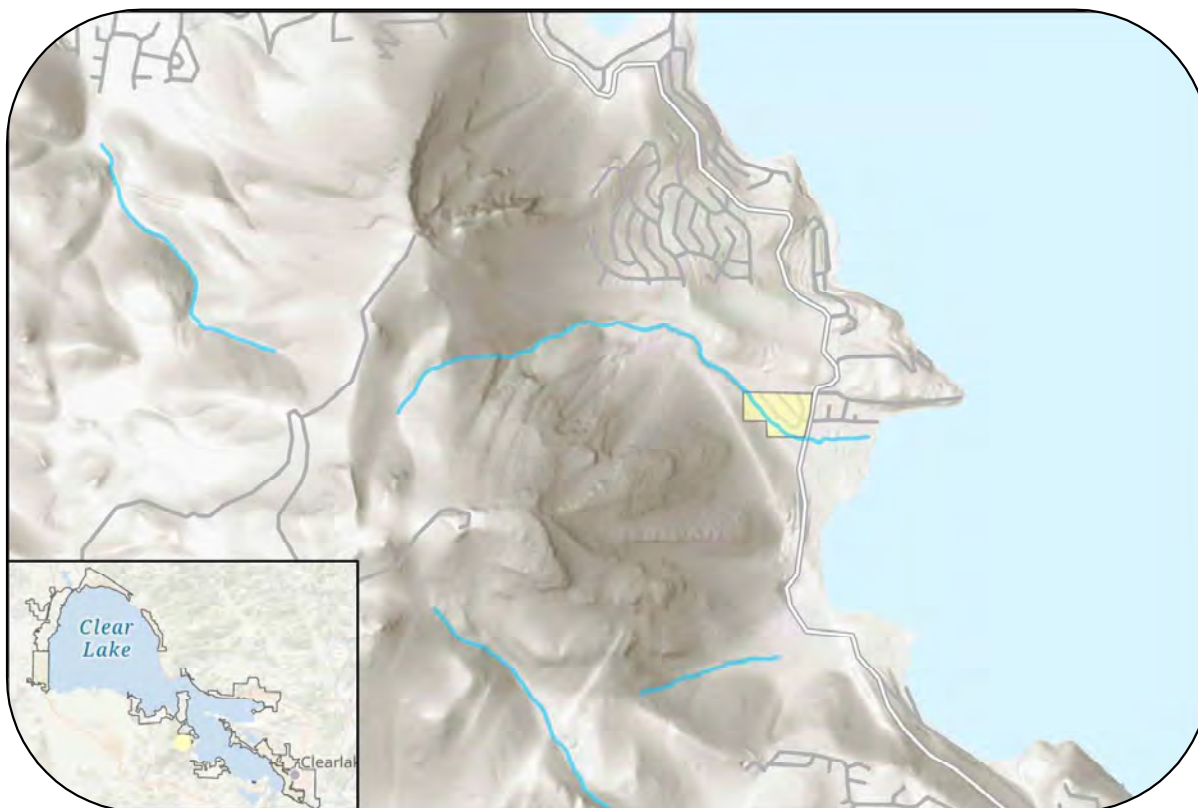
Figure 6.6.1: CWMWC System Boundary Map

The Clear Water Mutual Water Company (CWMWC) is located on the southwestern side of Clear Lake's Lower Arm (Figure 6.6.1). The CWMWC is a disadvantaged community (DAC) with 89 connections (88 residential and 1 commercial) and a population of 252. The system has one pressure zone, one surface water treatment plant, two storage tanks (an additional storage tank is under construction as of January 2023), and one booster pump station. Additional system information is outlined in Table 6.6.1.

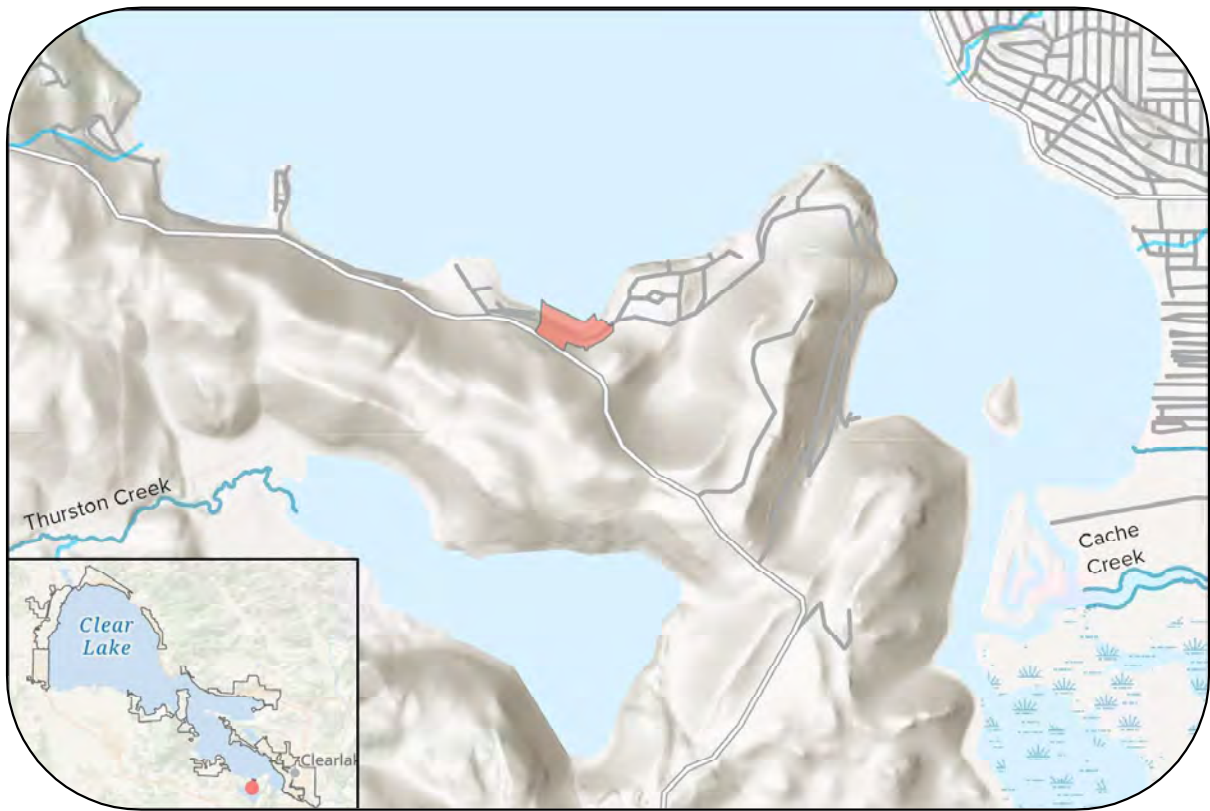
Figure 6.7.1: CBIC System Boundary Map

The Crescent Bay Improvement Company (CBIC) is located on the southeastern side of Clear Lake’s Lower Arm (Figure 6.7.1). As of 2022, the CBIC is not classified as a disadvantaged community (DAC). It has a total of 24 connections (24 residential and 0 commercial) and serves a year-round population of 18, which can swell to 72 during peak summer and weekends. The system has one pressure zone, one surface water treatment plant, three clearwells totaling 20,000 gallons and 10,000 gallons of additional storage. Additional system information is outlined in Table 6.7.1.

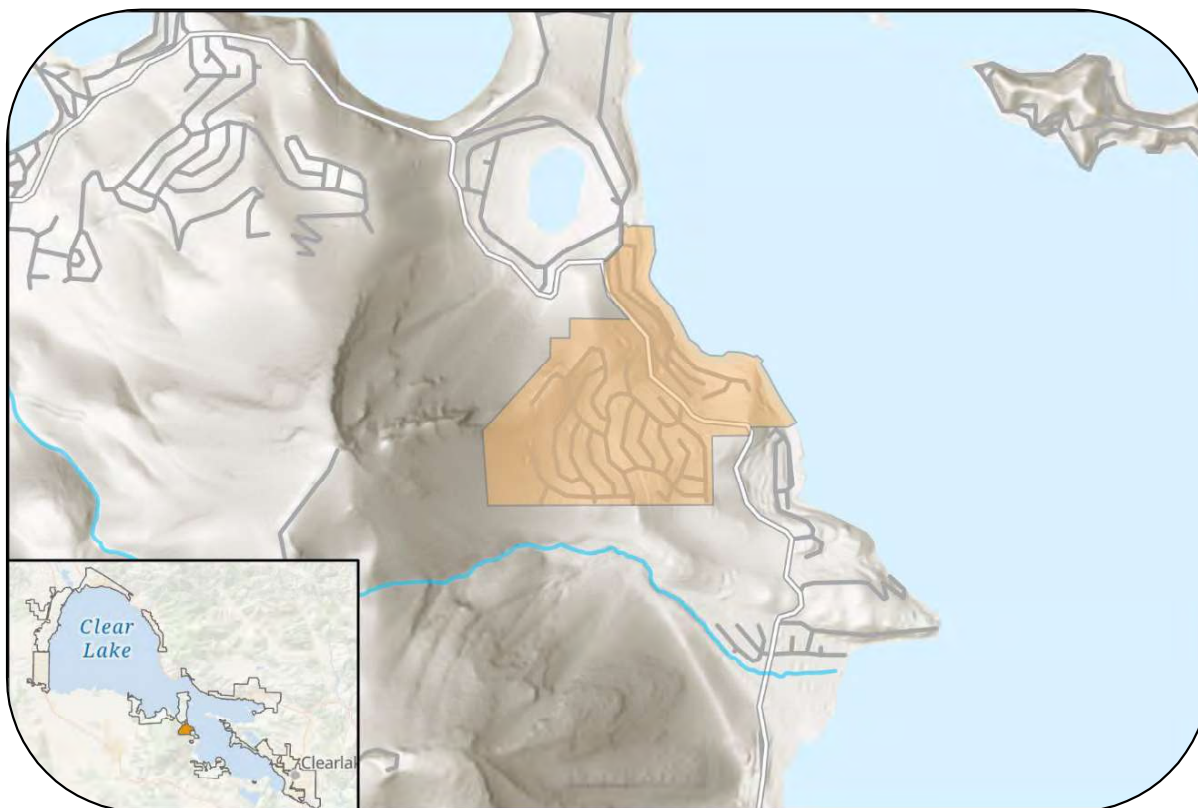
Figure 6.9.1: HVMWC System Boundary Map

The Harbor View Mutual Water Company (HVMWC) is located immediately southeast of Buckingham Peninsula on the Lower Arm of Clear Lake. The intake is in a quiescent cove on the eastern side of the peninsula (Figure 6.9.1). The HVMWC is a disadvantaged community (DAC). It has a total of 250 connections (250 residential and 0 commercial) and serves a population of 550. The system has three pressure zones, one surface water treatment plant, three storage tanks, and four booster pump stations. Additional system information is outlined in Table 6.9.1.

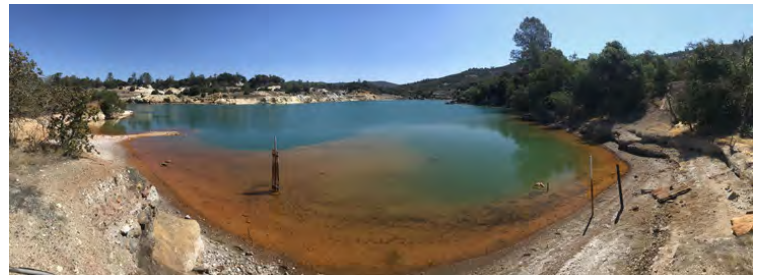
Close-up of Herman Impoundment water onsite.
